Pipeline & Gas Journal

Why Some Flange Isolation Kits Fail

By Jay Keldsen, Sales Director – Infrastructure Group, PSI/Pikotek, Houston

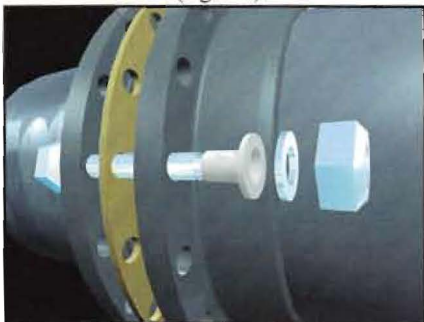
Flange isolation kits are critical components in pipeline operations where they separate dissimilar metals to prevent galvanic corrosion and provide electrical isolation for cathodic protection systems. Relatively low-cost but high-consequence, these kits consist of a gasket that both seals and electrically isolates the pipe joint, together with sleeves and washers to isolate the fasteners (Figure 1).

Figure 1: Isolation kit components.

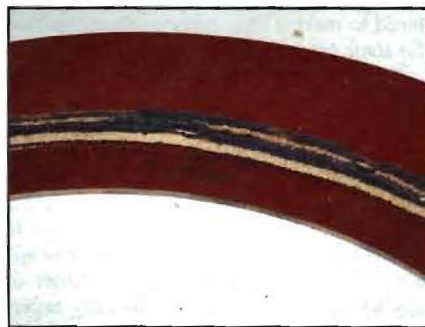
The gasket in Figure 3 failed on hydrotest. The quality of the laminate, sealing element and groove dimensions are all questionable.

Figure 3: Gasket for natural gas project.

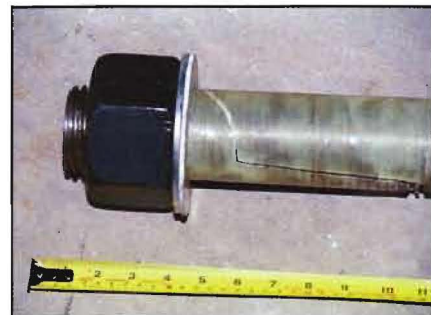
Figure 4: Bolt sleeve failure due to shear stresses.

The 45-degree angle with respect to the bolt's axis in Figure 4 shows that the sleeve failed in shear mode. The contractor ordered G-10 isolation washers and sleeves from one supplier and the steel washers from another. Normally the isolation and steel washers are supplied as part of a kit. In this case, the steel washers had a slightly smaller I.D. than the G-10 washers, so there was no clearance between the steel washers and the sleeve. As the nuts were tightened, they grabbed the sleeves and twisted them. To avoid this problem, both the steel and isolation washers must be manufactured to precise dimensions with matching I.D.s and O.D.s for more uniform loading and to allow the sleeve material to fit within the I.D.

Specifications for flange isolation kit sleeve material frequently call for the sleeve to be "full length", an undefined measure for which there are no known industry standards. A better specification would require the minimum

standard length of the sleeve to extend at least halfway into the back-up steel washers.

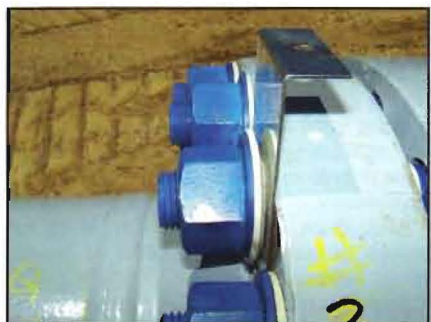
In Figure 5, the white isolation washer has "squished" out from the compressive load of the blue steel washer. In this case, the problem was caused by using the wrong washer material for the loads being applied and the dimensional variance between the steel and isolation washers. It also can be caused by overloading the compressive strength of the washer.

Figure 5.: Over-compressed white isolation washer.
